Use of the damage rating index (dri) to evaluate level of deterioration due to alkali-silica reaction in 34-year old concrete from the Sudbury area

Carole Anne MacDonald, Soils and Aggregates Section, Materials Engineering and Research Office, Ministry of Transportation, Downsview, ON, Canada, caroleanne.macdonald@ontario.ca

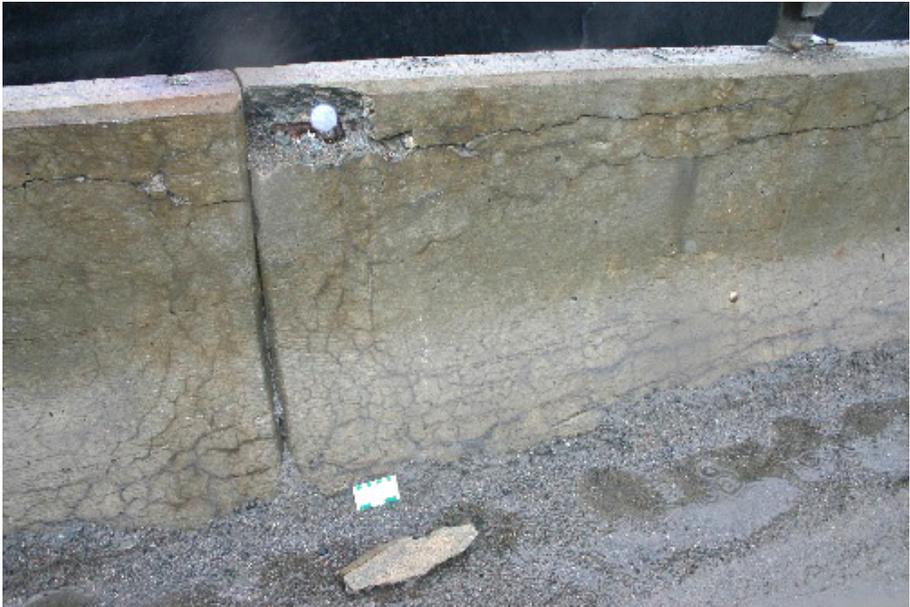
Figure 1: Highly deteriorated barrier walls from the East-North Ramp Bridge, April 2013.

Materials acquired in 2012 and 2013 include portions of an abutment from one of the main highway bridges as well as sections of barrier walls from two on/off ramp bridges over a railway line. The two ramp bridges had visibly different levels of deterioration due to differences in traffic levels, exposure to moisture and de-icing salts, and relative amounts of frost (Figures 1 and 2). In addition to full sections of barrier walls and abutment pieces, several tons of crushed concrete demolition waste (RCC) were shipped to an MTO site in the Toronto area for further study.

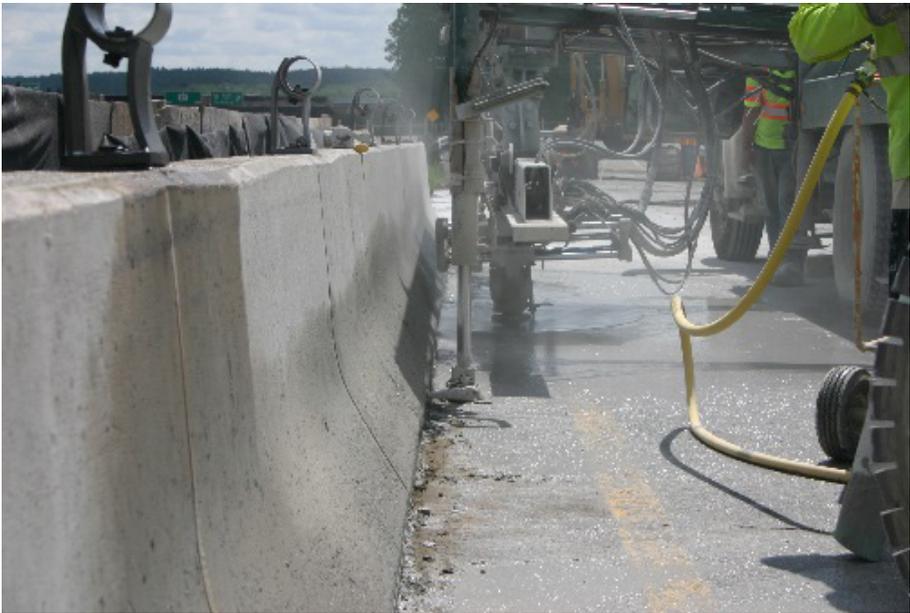
Figure 2: Low deteriorated barrier walls from the North-West Ramp Bridge, June 2013.

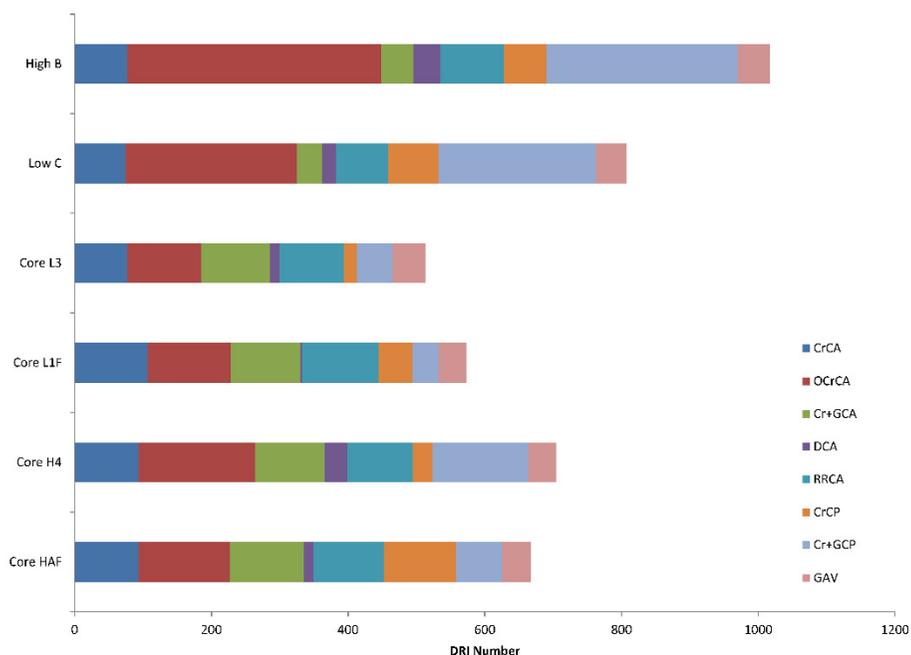
Figure 3: Chart of DRIs for each of the cores examined by Method 1 showing the relative contribution to the DRI that the individual defect types or petrographic damage features provide.

High and low deterioration cores subjected to 1-year of testing at 38 °C and >95 R.H. showed nearly identical increases to their DRIs of 313 and 295 respectively as compared with similarly prepared cores that were not subjected to the same test conditions (Table 4). Although the relative change in DRIs during the 1-year test period was nearly the same, the recorded expansions were quite different. Expansion of the low deterioration cores (~0.10%) was nearly double that of the high deterioration cores (~0.05%) (Table 4). Based on the measured differences in expansion, one might conclude that this is a symptom of a slowing rate of reaction, and/or that the alkalis and available silica are depleting in the highly deteriorated concrete. However, closer examination of Figure 3 that shows the relative contribution

of different features to the DRI, reveals a marked increase in those features that are most indicative of severe deterioration of concrete due to ASR, e.g., CrCP, Cr+GCP, OCrCA and DCA. Comparison of the detailed DRI results for cores High B and Low C show that core High B appears to have relatively more features counted in several of the categories, mainly open cracks in the coarse aggregate and cracks in the cement paste containing ASR gel (Figure 3). Comparison of the graph bars for cores H4 and High B and cores L3 and Low C both show large increases in the number of open cracks in the coarse aggregate and cracks in the cement paste containing ASR gel over the 1-year test period.

The high DRIs reported for both the low and high deterioration cores correlate well with the type and frequency of damage features present in the concrete that are directly attributable to ASR (Figure 3). In particular the abundance of CrCP and Cr+GCP indicates a high level of damage. The relatively high abundance of OCrCA is exclusively due to ASR as the cracks occur mostly within the reactive rock types and often have traces of ASR gel visible within the cracks. These reactive rock types (argillite, greywacke, arkose-arenite) do not normally have these visible open cracks prior to incorporation in concrete. Figure 3 also shows how different parts of a structure or different structures built with the same materials and that are of the same age can exhibit different levels of damage. The different levels of damage in this case is directly related to the different exposure conditions as the bridge with the high deterioration walls was known to have a higher traffic volume with relatively more exposure to moisture and deicing salts.
