Microstructural investigations on an abandoned 1935 concrete bridge

Vincent Thiéry IMT Lille-Douai, LGCgE & CERI “Materials and Processes”, 764 Boulevard Lahure, F-59500 DOUAI, France. vincent.thiery@imt-lille-douai.fr

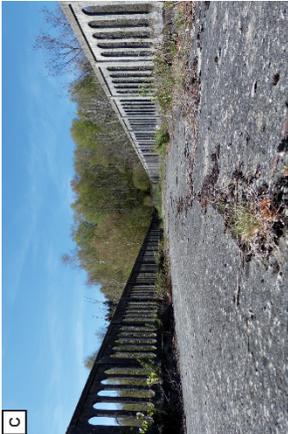
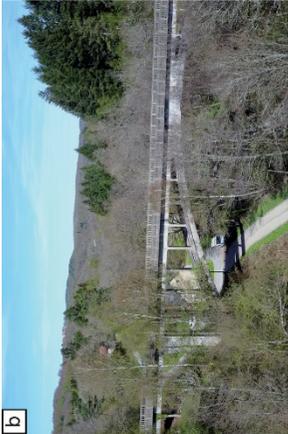
Figure 1. a-c : the bridge (a: postcard from 1936 or 1937, author's personal collection) and d-o: associated microstructures. See text for explanations.

The present study deals with a bridge located in the center of France, built from June 1934 to August 1935; its inauguration took place on Sunday, October the 27th, 1935 (Figure 1a). It quickly showed some deterioration. During the 1960's, some limitations regarding the maximum weight of vehicles allowed to use the bridge were implemented. It has been definitely closed in 1980. Since then, it is left in an abandoned state (Figure 1b and c): cracking and steel reinforcement corrosion occurs in numerous places of the bridge.

The region in which the bridge has been built belongs to one of the widest granitic massifs of France, namely the Guéret massif [10], the aggregates and sand used are of local source. Most of the aggregates consist on a dark granite (Figure 1d&g) in which plagioclase feldspar shows some evidence of sericitization (Figure 1d&e) transformation in fine-grained phyllosilicates, cordierite is generally not fresh and pinitized. Quartz generally display undulose extinction (Figure 1e). Some aggregates have revealed themselves to be rich in pyrite (Figure 1f), both inside the grains or at their surface. The precise source of the aggregate is unknown, several abandoned quarries being present in the vicinity.

Ground slabs, compared under white and UV light, show well developed cracking occurring both in the cement paste and at the interface between aggregates and cement paste (Figure 1g&h).

Ettringite, actually an intermediate between ettringite and thaumasite (EDS analyses are not detailed in the present extended abstract), is abundant in concrete sampled from the upper part of the deck. Firstly, all porosities are totally filled by this fibrous phase (Figure 1i), generally forming radiating crystallizations. Then, many cracks, occurring along debonded aggregates, in the cement paste, or cutting aggregates, are filled by this fibrous phase; the elongation of the fibers is perpendicular to the cracks (Figure 1j). Calcite crystals, 20 micrometers in diameter (Figure 1k) occur locally within a cement paste mostly transformed in ettringite-thaumasite (Figure 1l).

Contrarily to the samples taken above the deck, the cement paste of the concrete from below the deck, at least on the place of sampling, is not grey, but orange-rose. Under the microscope, in thin sections, complementarily to unhydrated Portland clinker particles (Figure 1m), it shows abundance of orange particles of 50-100 micrometers in diameter (Figure 1n).

In thin section, their individual microstructure is difficult to decipher because they are very finely grained. Under the SEM, they show very poor contrast with their matrix (i.e. the cement paste) in BSE mode (Figure 1o). EDS results (not displayed here)

indicate very impure calcium silicates and aluminates. Those latter forms an incipient interstitial phase between calcium silicates.

The orange particles observed in the cement paste of concrete from under the deck consist most probably of unburnt cement: they show a very poor development of phases, in which an incipient interstitial phase lies between poorly formed calcium silicates. This is coherent with a problem of burning of the cement, probably not burnt enough.

The abundance of ettringite-thaumasite in concrete from the upper part of the deck shows microstructural similarities with several concrete pathologies. Locally, ettringite-thaumasite is present as rims around the aggregates, but not all around as would be the case in delayed ettringite formation [12]. The cement paste is also completely cracked and locally partly replaced by ettringite-thaumasite. This shows some similarities with the thaumasite form of sulfate attack, especially concerning the fact that there is also calcite present as individual crystals within the damaged paste as in the case of “popcorn calcite deposition” [13]. The source of sulfur is to be found in the aggregates which are, in the present case, unusually rich in pyrite/pyrrhotite for granite. The use of such sulfide-rich aggregates is known to be deleterious for concrete [14]. Finally, in order to provide the same chronological comparison as for alkali-aggregate reaction (see above), it is worth noting that the first case of DEF in France has been described only in 1997 [15].
